TROUBLE SHOOTING
for KH-4500

KIWA MACHINERY CO., LTD.

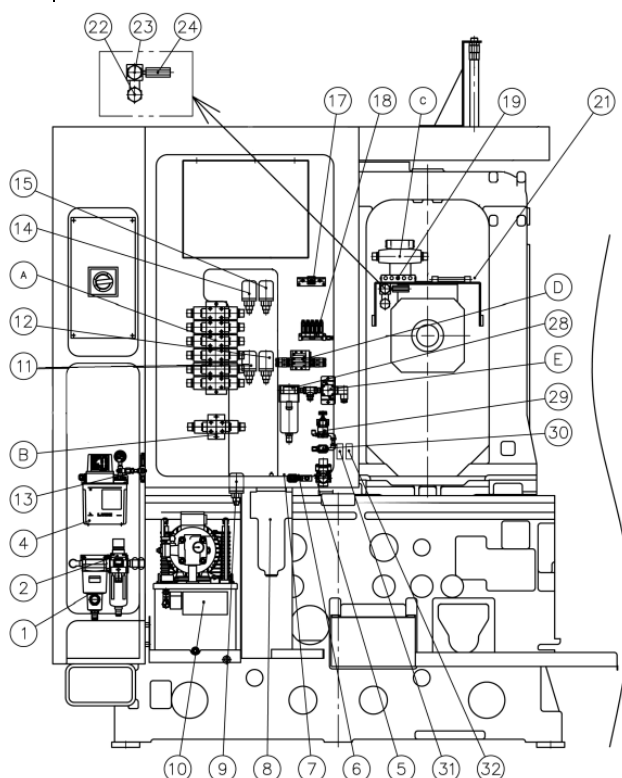
No.1300 NO PALLET SITTING<PS6>

Description/Possible Causes	Remedy
<p>Sensor <PS6> (7 on the illustration below) for pallet sitting confirmation doesn't turn ON because of the following:</p> <ol style="list-style-type: none"> 1. Chips get between Taper cones on Rotary table and Taper blocks on Pallet. 2. Insufficient air pressure 3. Insufficient air flow rate 4. Air leaking from the rotary joint area of Rotary table 5. Air leaking from gaps between Pallet and Taper blocks on it 	<ol style="list-style-type: none"> 1. Move the pallet to the APC position (perform G91G30Z0B0), and raise the pallet in Manual operation. Then open the operator door and clean surfaces between Rotary table and Pallet. 2. Disconnect the hose (on Rotary table side) from Sensor <PS6>, and plug the opened outlet of the sensor. Check if the pressure indicated on the sensor goes up to 0.15 MPa. If not, adjust Regulator (5 below) to raise the pressure. 3. If air pressure is OK, check the condition of Flow control valve (6 below). It should be opened by six turns from the closed position. 4. If, for reasons of machine deterioration, six turns are not enough, you may open it further until the pressure becomes 0.15 MPa. (There is a limit, though.)

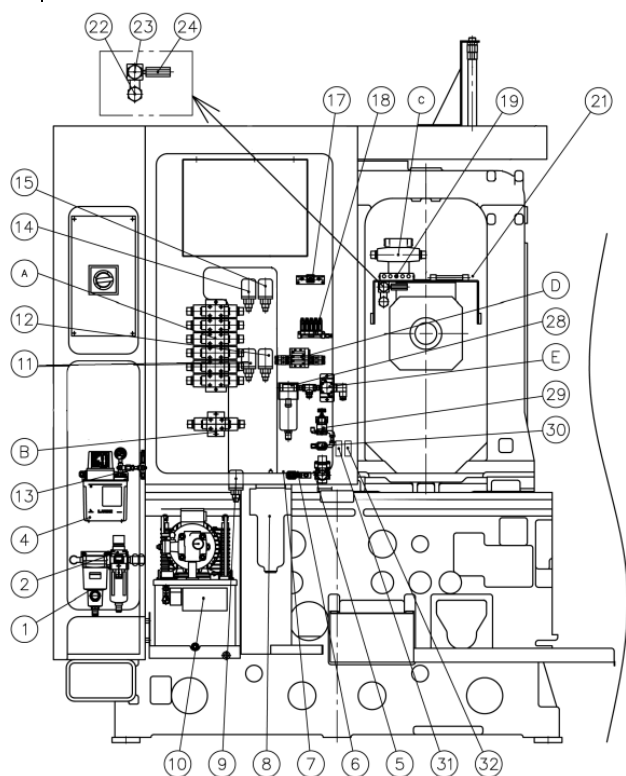
No.2004 B AXIS AIR PURGE PRESSURE IS LOW<PS126>

Description/Possible Causes	Remedy
<p>Air pressure for air seal in B-axis rotary table is low because of the following:</p> <ol style="list-style-type: none"> 1. The source air pressure gets low. 2. Air leaking from the rotary table 3. Failure of Pressure switch <PS126> (30 on the illustration below) 	<ol style="list-style-type: none"> 1. Remove the hose on the rotary table side of T-joint connected to Pressure switch <PS126>, and plug the opened port of the T-joint. Check the pressure of Regulator (29 below). If it is lower than 0.02 MPa, raise it to 0.02 MPa. Also, check that Pressure switch <PS126> indicates 0.02 MPa, too. 2. If setting of Regulator is OK, air is leaking from the rotary table. Replacement of seals of the rotary table is necessary. (If leak is not so intense, you may increase the air pressure up to 0.02 MPa and see how it goes for a while.) 3. If the display of Pressure switch is strange, or the message appears even though the pressure is normal, check the set pressure of Pressure switch. If the set pressure is correct, replace the pressure switch.

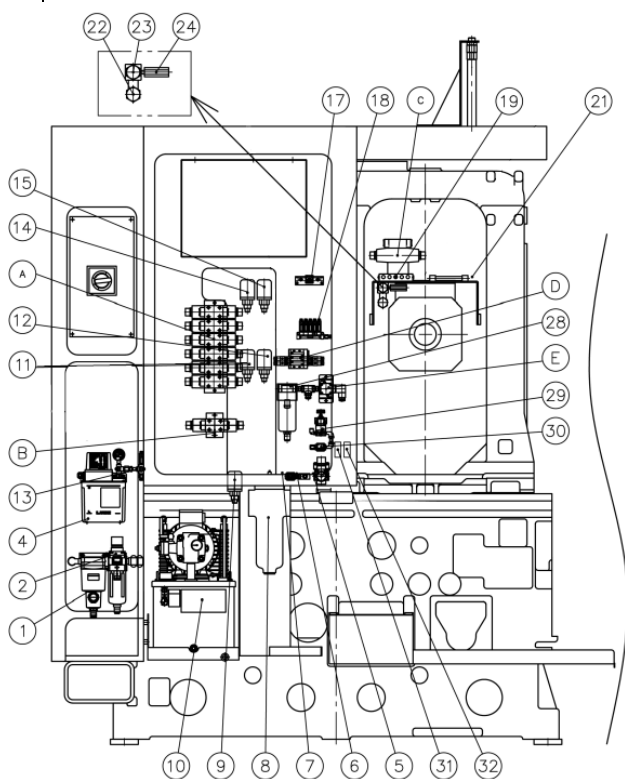
No.2092 NO PALLET SITTING CONFIRMATION <PS6>

Description/Possible Causes	Remedy
<p>Sensor <PS6> (7 on the illustration below) for pallet sitting confirmation doesn't turn ON because of the following:</p> <ol style="list-style-type: none"> 1. Chips get between Taper cones on Rotary table and Taper blocks on Pallet. 2. Insufficient air pressure 3. Insufficient air flow rate 4. Air leaking from the rotary joint area of Rotary table 5. Air leaking from gaps between Pallet and Taper blocks on it 	<ol style="list-style-type: none"> 1. Move the pallet to the APC position (perform G91G30Z0B0), and raise the pallet in Manual operation. Then open the operator door and clean surfaces between Rotary table and Pallet. 2. Disconnect the hose (on Rotary table side) from Sensor <PS6>, and plug the opened outlet of the sensor. Check if the pressure indicated on the sensor goes up to 0.15 MPa. If not, adjust Regulator (5 below) to raise the pressure. 3. If air pressure is OK, check the condition of Flow control valve (6 below). It should be opened by six turns from the closed position. 4. If, for reasons of machine deterioration, six turns are not enough, you may open it further until the pressure becomes 0.15 MPa. (There is a limit, though.)
